# ***i960<sup>®</sup> VH Embedded-PCI Processor***

*Specification Update*

*August 2004*

Order Number: **273174-011**

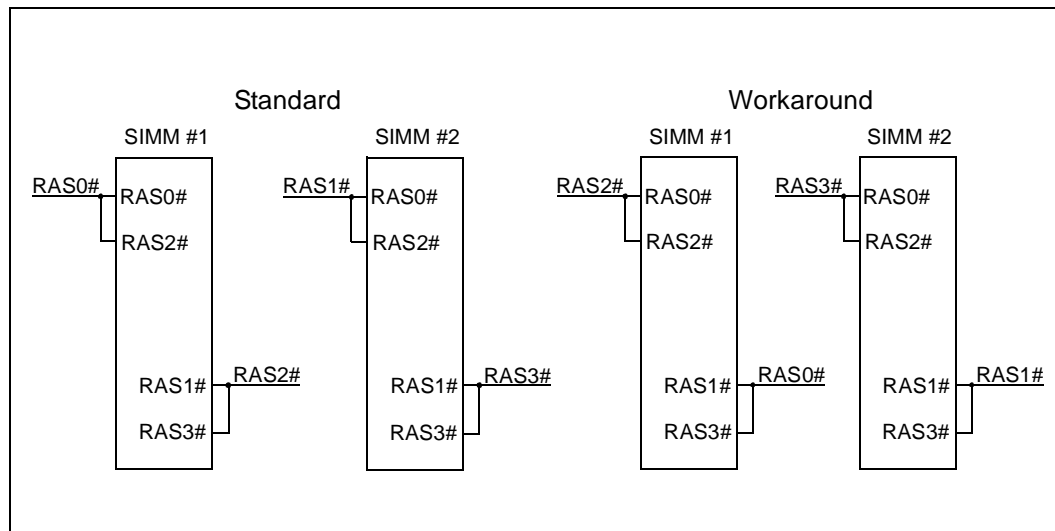
**Figure 1. DRAM RAS# Configurations**

**Problem:** The 80960VH MCU supports from one to four banks of DRAM. When the memory subsystem contains fewer than the maximum number of banks used in the 80960VH design, certain addresses may cause the MCU to assert a RAS# to an empty bank. [Table 1](#) shows the relationship between the 80960 local memory address and the RAS# asserted by the MCU.

**Implication:** The MCU may assert RAS# to access a nonexistent 80960VH DRAM bank. This may occur when the number of DRAM banks installed is less than the maximum number of DRAM banks used in the 80960VH design. Two examples of when this problem can occur are:

When the 80960VH initializes from 80960 local memory instead of FLASH/ROM, the 80960VH's first instruction fetch of the IBR is hard-coded to address 0xFEFF FF30. When the MCU reads this address, it asserts RAS2# or RAS3#, depending on the DRAM bank/leaf size.

1. A read of the IBR is issued to 0xFEFF FF30.
2. Since 4-Mbytes is the DRAM bank/leaf size, the MCU decodes the next two higher order bits 23:22 from within the address to determine which RAS# signal to assert during the DRAM access.
3. IBR address bits 23:22 = 11<sub>2</sub>, and the MCU asserts RAS3# (See [Table 1](#)).
4. RAS3# selects an unpopulated DRAM bank, the IBR will not be read, and the device will not initialize.

### CASE 2 WORKAROUND - Initializing from 80960VH DRAM instead of FLASH/ROM

In a standard DRAM configuration, RAS0# and RAS1# are routed to the front sides of the SIMMs, and RAS2# and RAS3# are routed to the back sides of the SIMMs. To implement this workaround, swap RAS0# and RAS2# and swap RAS1# and RAS3#. This routes RAS2# and RAS3# to the front sides of their respective SIMMs, and routes RAS0# and RAS1# to the back sides of their respective SIMMs (See [Figure 1](#)). To determine which RAS# is asserted for a particular address and DRAM configuration, see [Table 1](#).

When initializing from 80960VH DRAM, the first instruction fetch of the IBR is hard-coded to address 0xFEFF FF30; as a result, A23:22 = 11<sub>2</sub> and RAS3# is asserted. With the workaround in place, the RAS# lines are swapped and RAS3# is connected to the front side of the second SIMM and the IBR can be read.
