82546EB Gigabit Ethernet Controller Specification Update

September 26, 2006

The *82546EB* Gigabit Ethernet Controller may contain design defects or errors known as errata that may cause the product to deviate from published specifications. Current characterized errata are documented in this Specification Update.

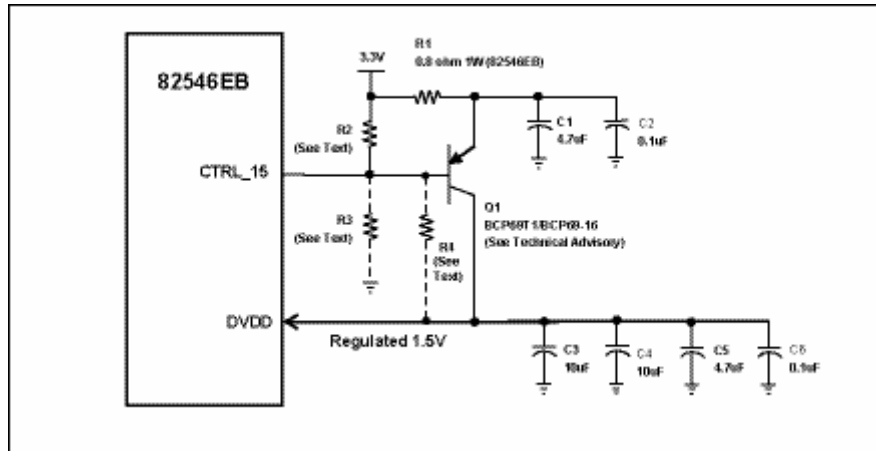
8. 1.5V Regulator Control Circuit Start Up

- Implication:** When drive is absent on the CTRL_15 output, only leakage current from the CTRL_15 output will be present. Depending on the amount of leakage current and the gain (Beta) of the external PNP transistor, there may be insufficient collector current ($I_C = I_B * \text{Beta}$) to adequately supply the 1.5V rail, and the 1.5V regulator circuit may not turn on. The 1.5V rail requires a minimum collector current of 5 mA to be generated and a 1.5V rail voltage of at least 600 mV to ensure that the digital portion of the circuit turns on correctly.

- When the 1.5V regulator control output fails, the 2.5V regulator control output(s) may also fail, driving the 2.5V supply toward either 0V or the 3.3V rail. The absence of one or both of the 1.5V and/or 2.5V supplies prevents the Ethernet controller from operating correctly.

- Due to variations in PNP minimum/maximum transistor gain, this circuit must adhere to specific requirements for the PNP transistor, R3 resistor value, and configuration of the 82546EB controller. Follow **workaround instructions** in Technical Advisory TA-149, "Possibility of 1.5 Voltage Regulator Failures on 82546EB LOM Designs." **Note:** Workarounds differ among the 82540EM and 82546EB controllers and each controller has a separate technical advisory.

- Systems that generate 1.5V without using the Ethernet controller's onboard regulator control (at a central power supply, for example) do not need a workaround. No changes are required for the 2.5V regulator circuit.

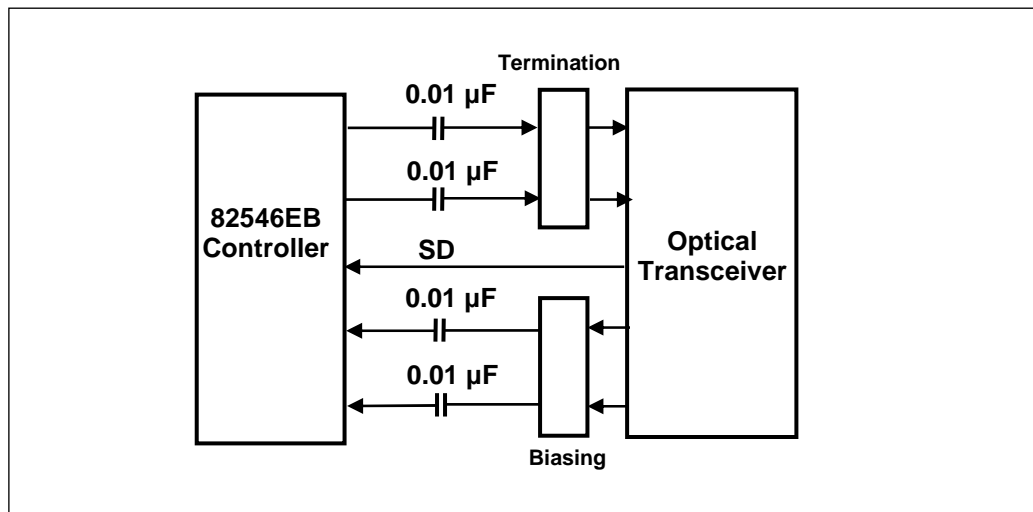
82546EB fiber-based applications will use the SERDES interface to drive a 1000BASE-SX or 1000BASE-LX optical transceiver as illustrated in the following figure. The 82546EB controller is internally terminated, so no external termination is required.

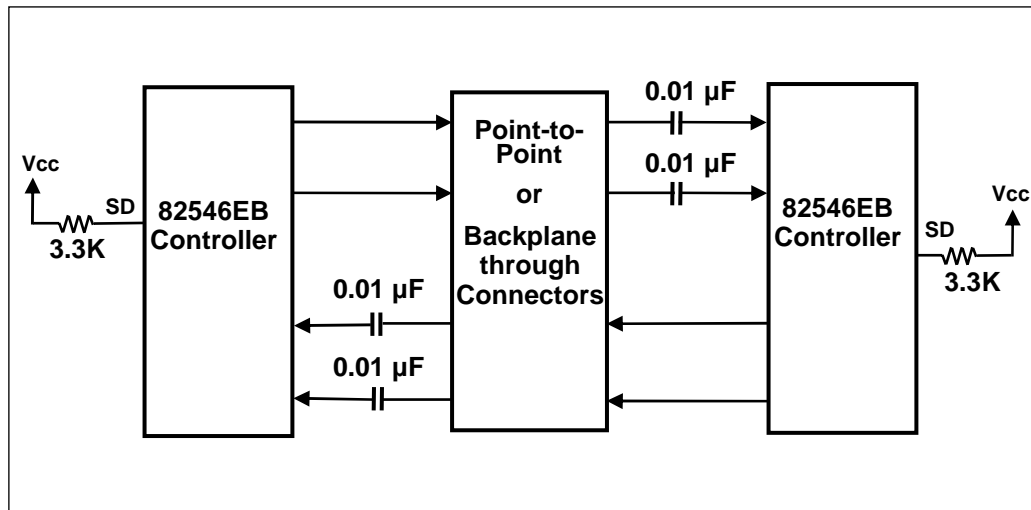
Alternatively, the 82546EB controller may be used in short haul gigabit backplane data applications without transceivers and optical fibers. No special termination is required because the 82546EB device is internally terminated. The figure below illustrates a gigabit backplane or point-to-point circuit based on the 82546EB device:

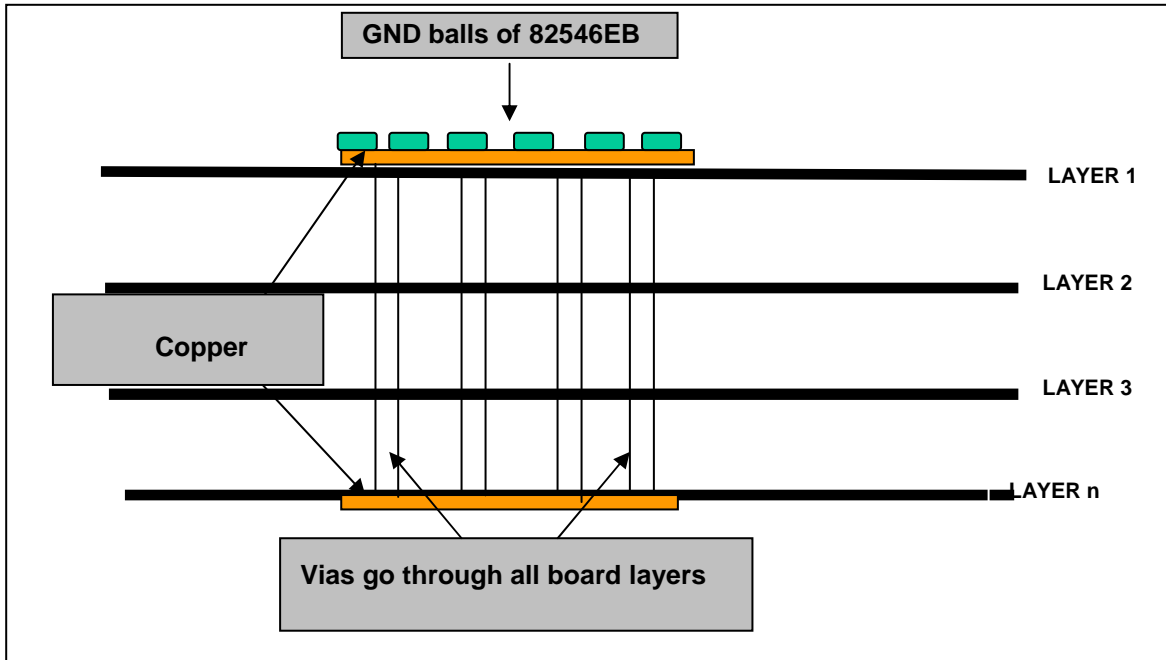
Following the above recommendations can dramatically reduce the case temperature of the 82546EB Gigabit Ethernet Controller, keeping the junction temperature within safe limits. In one experiment, using 2 oz. copper instead of 1 oz. copper on six layer circuit boards reduced the measured case temperature from approximately 87°C to 72 °C.
