Intel[®] 82575EB Gigabit Ethernet Controller Specification Update

LAN Access Division (LAD)

Revision: 2.67
December 2011

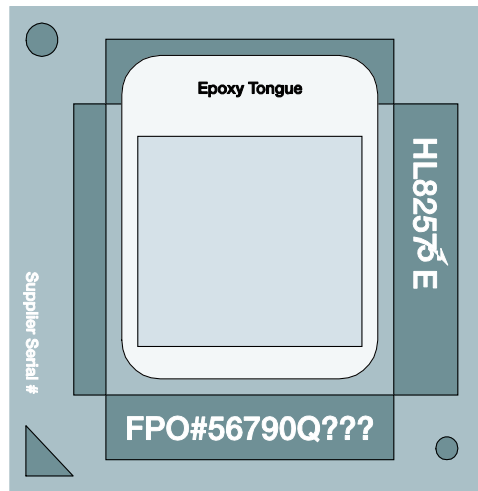
Figure 1. Device Identifying Marks (Similar)

Lead-free parts have "JL" as the prefix for the product code (vs. "HL") and that the "Q" designator refers to the Q Specification number in the table.

Devices can also have a "GB" marking; these devices are used only on Intel network interface adapters. The "GB" is functionally equivalent to the "EB" device.

There is an internal designator visible as a dash on the die side of some packages. The location may differ. The mark (looks like a dash, approximately 300X1000 μm in size) does not impact function.
