Monthly Specification Update

Intel® Server Boards S5000PSL and S5000XSL

Intel Order Number D62900-001

February, 2011

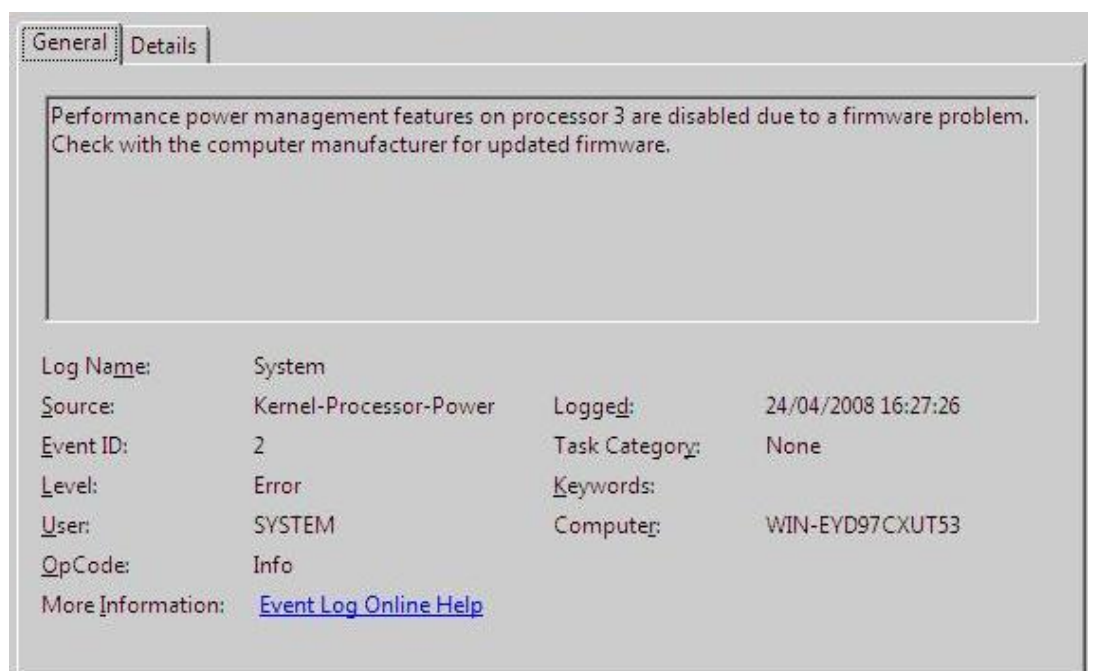
50. Microsoft Windows Server 2008* and/or Microsoft Windows Vista* may report Performance Power Management error

Problem Microsoft Windows Server 2008* and/or Microsoft Windows Vista* in Intel® Server Board S5000PSL and/or Intel® Workstation Board may have a Performance Power Management error in the Microsoft Windows System Event Log* like the following illustration:

Implication Current version of the BIOS displays a default dummy PSS object (P-State info) in ACPI space for processors that do not support Enhanced Intel® SpeedStep® Technology to indicate no P-State supported; however, this is interpreted as a Performance Power Management error in the Operating System log. This is a harmless message and does not impact system performance or functionality.

Status This erratum is fixed by BIOS91.6
