Intel[®] Celeron[®] Processor Specification Update

Release Date: August 2007

Document Number: 243748-051

The Intel[®] Celeron[®] processor may contain design defects or errors known as errata, which may cause the product to deviate from published specifications. Current characterized errata are documented in this Specification Update.

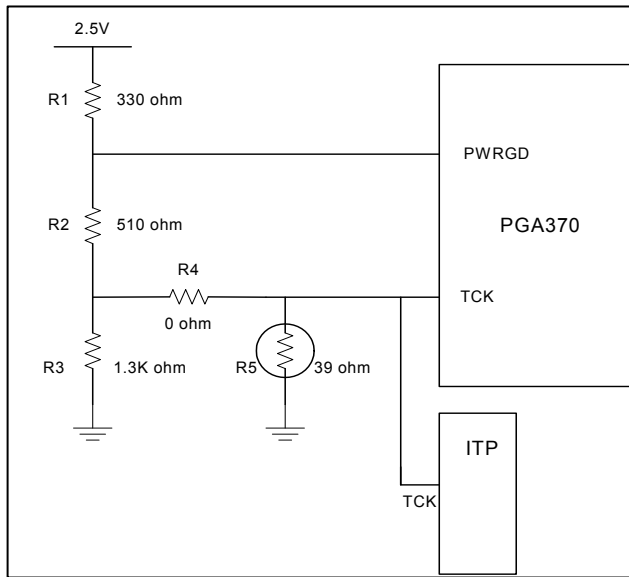
Figure 1 Celeron® on 0.13 Micron Processor 256K Platforms Workaround

In addition, the example workaround circuits shown do not support production motherboard test methodologies that require the use of the processor JTAG/TAP port. Alternative workaround solutions must be found if such test capability is required.

For Production Boards:
Depopulate R5

To use ITP:
Install R5, Depopulate R4
