# Intel® Media Processor CE 3100

## Errata Update

*Revision 1.6*

Reference Number: E51472-001

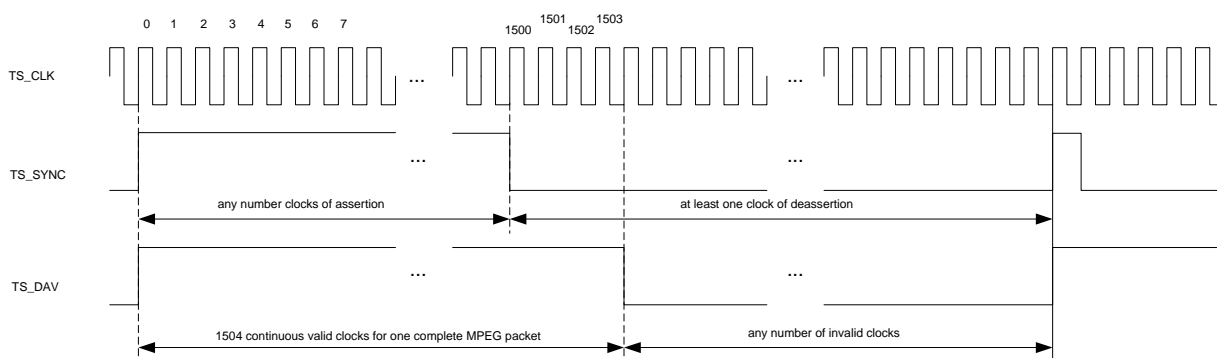
**Figure 1. Serial Transport Interface Timing with Continuous DAV**

Transport Stream devices must conform to the Intel® Media Processor CE 3100 required timing specs. Below are the timing diagrams that can be supported.

Note: Devices connected to the Intel® Media Processor CE 3100 serial transport stream input must conform to the timing specifications of the device. The Intel® Media Processor CE 3100 TS Input requires an even byte number of clocks for the 188 byte packet, and expects the data to be byte-aligned. Please refer to EMTS (Electrical Mechanical Thermal Specification) for detail information.
