Intel[®] Celeron[®] M Processor

Specification Update

May 2012

Revision 043

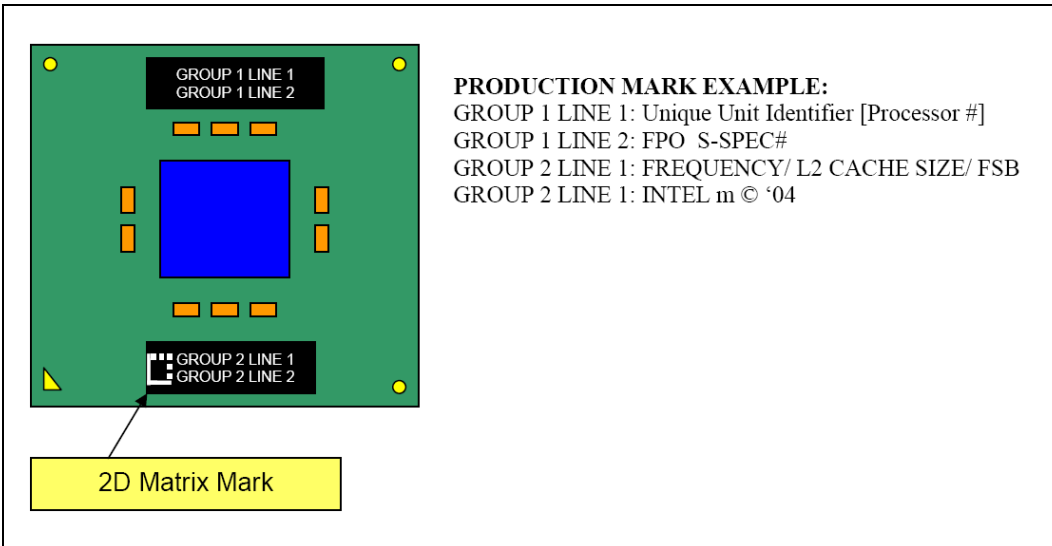
Figure 4. Intel® Celeron® M Processor on 65-nm Process (Micro-FCPGA/FCBGA) S-Spec Markings
