# Intel<sup>®</sup> Core<sup>™</sup>2 Duo and Intel<sup>®</sup> Core<sup>™</sup>2 Solo Processor for Intel<sup>®</sup> Centrino<sup>®</sup> Duo Processor Technology

## Intel<sup>®</sup> Celeron<sup>®</sup> Processor 500 Series

### Specification Update

*Revision 026*

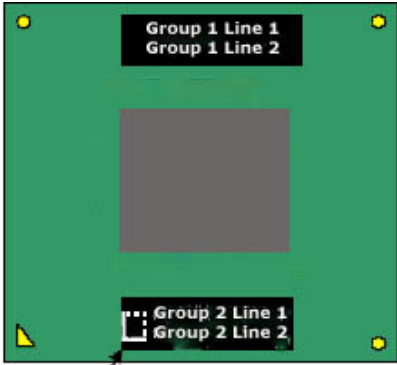
Figure 2. Intel® Core™2 Duo Mobile Processor (Micro-FCPGA/FCBGA) Production Markings

The diagram shows a green square representing the processor package. In the top-left corner, there is a black box containing the text "Group 1 Line 1" and "Group 1 Line 2". In the bottom-left corner, there is a black box containing the text "Group 2 Line 1" and "Group 2 Line 2". A yellow box labeled "2D Matrix Mark" has an arrow pointing to the bottom-left corner of the package.

**Production MARK EXAMPLE:**  
Group 1 Line 1: Unit Identifier\* Processor #  
Group 1 Line 2: FPO SSPEC#

\* Intel Core 2 Duo mobile processors have a unit identifier of LF80537 for Micro-FCPGA parts and LE80537 for Micro-FCBGA parts.

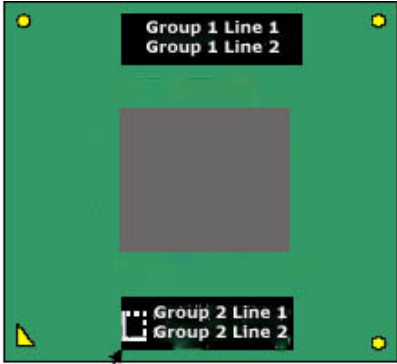
Figure 3. Intel® Celeron® Processor 500 Series (Micro-FCPGA) Markings

The diagram shows a green square representing the processor package. In the top-left corner, there is a black box containing the text "Group 1 Line 1" and "Group 1 Line 2". In the bottom-left corner, there is a black box containing the text "Group 2 Line 1" and "Group 2 Line 2". A yellow box labeled "2D Matrix Mark" has an arrow pointing to the bottom-left corner of the package.

**SAMPLE MARK EXAMPLE:**  
Group 1 Line 1: Unit Identifier ---  
Group 1 Line 2: FPO S-Spec#
