Intel® 82574 Family Gigabit Ethernet Controller Specification Update

January 2012
Revision 3.5

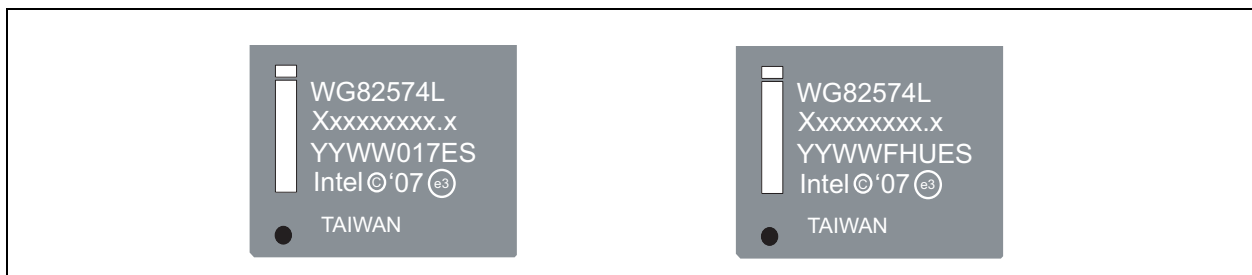
Figure 1. Engineering Samples Top Marking Example With Identifying Marks
