Intel[®] Core[™] i7-800 and i5-700 Desktop Processor Series

Specification Update

November 2009

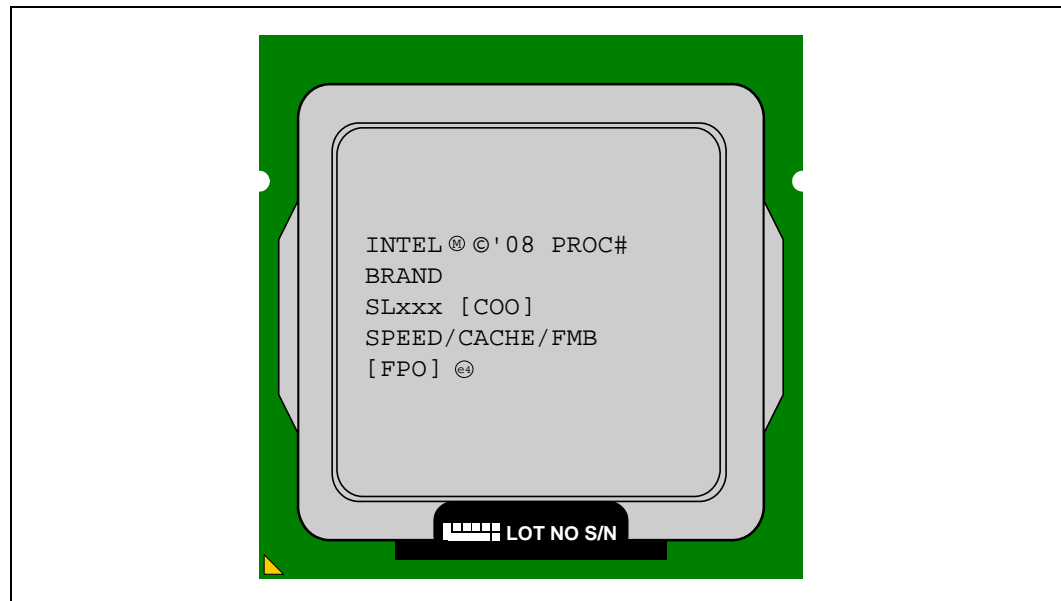
Figure 1. Processor Production Top-side Markings (Example)

The processor stepping can be identified by the following component markings.
