Intel[®] Pentium[®] M Processor

Specification Update

August 2008

Document Number: 252665-034

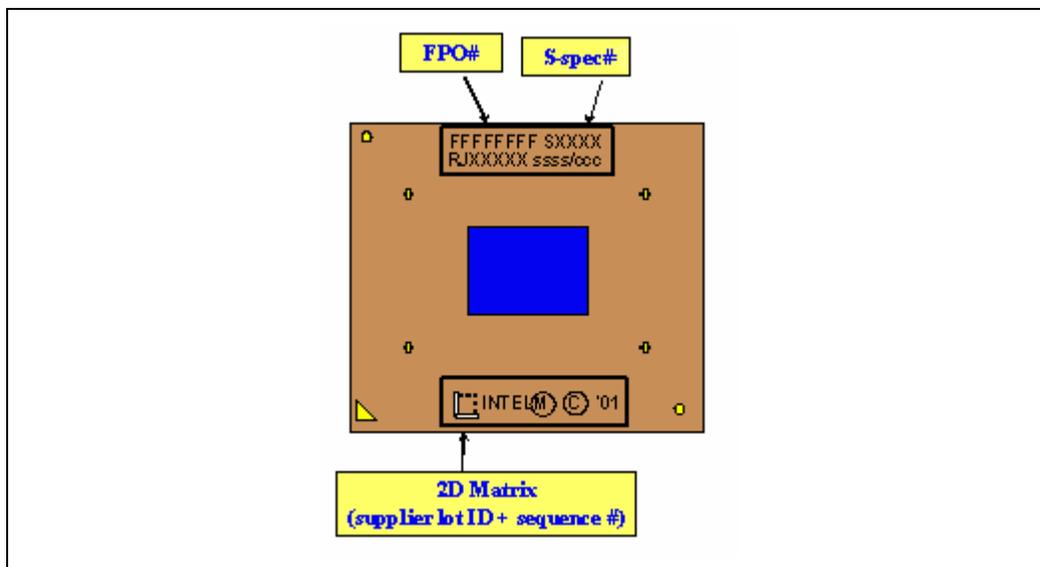
Figure 1. Intel Pentium M Processor (Micro-FCPGA/FCBGA) Markings

Component Marking Information
